# TECHNICAL INSPECTION REPORT

U.S.S. PENSACOLA (CA24)

TEST ABLE

OPERATION CROSSROADS

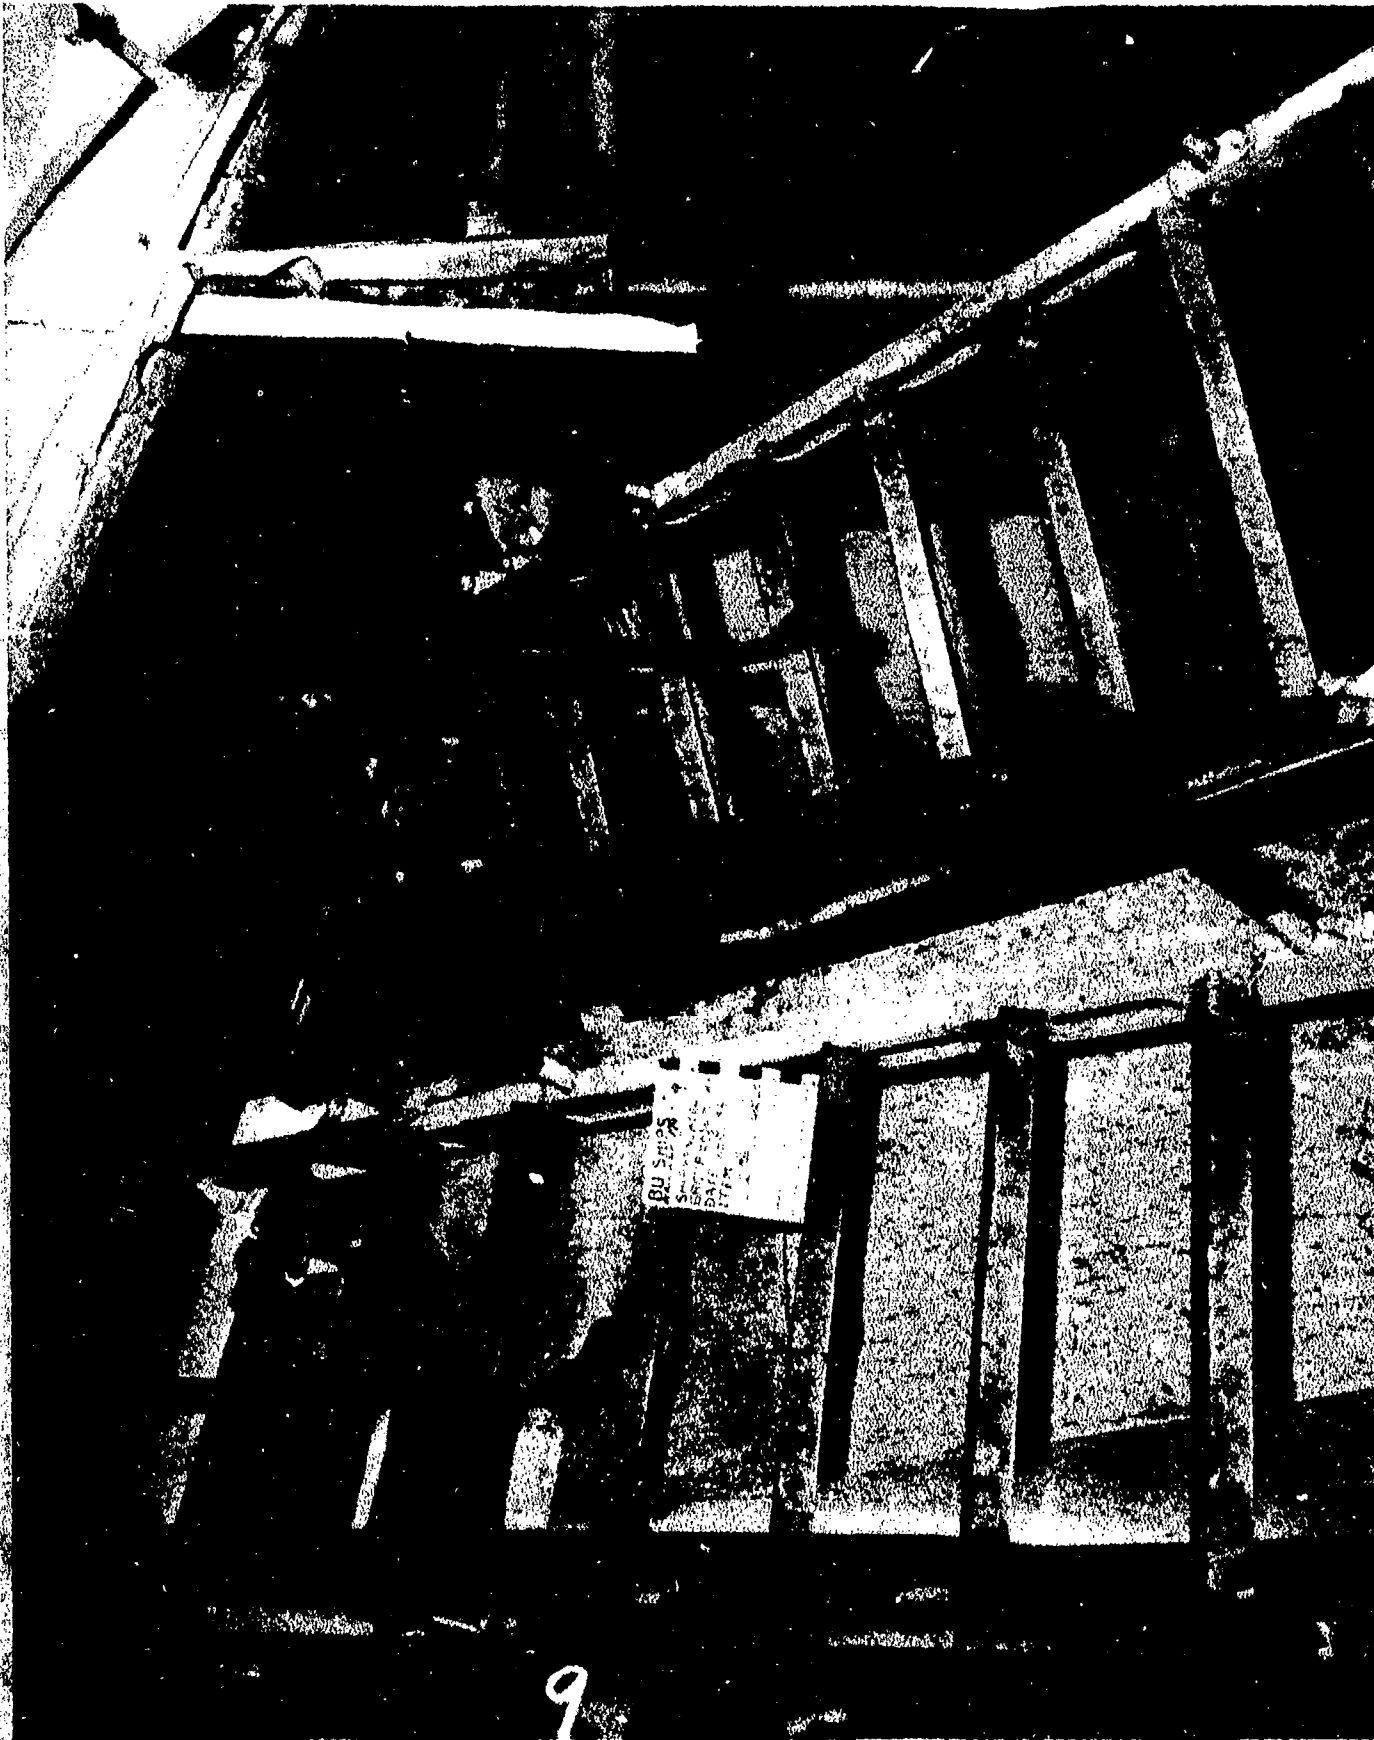
AA-CR-68-1767-9. C-201L. Looking to starboard on 2nd deck at frame 61 in crew's space showing failure of main deck longitudinal at frame 62 1/2.

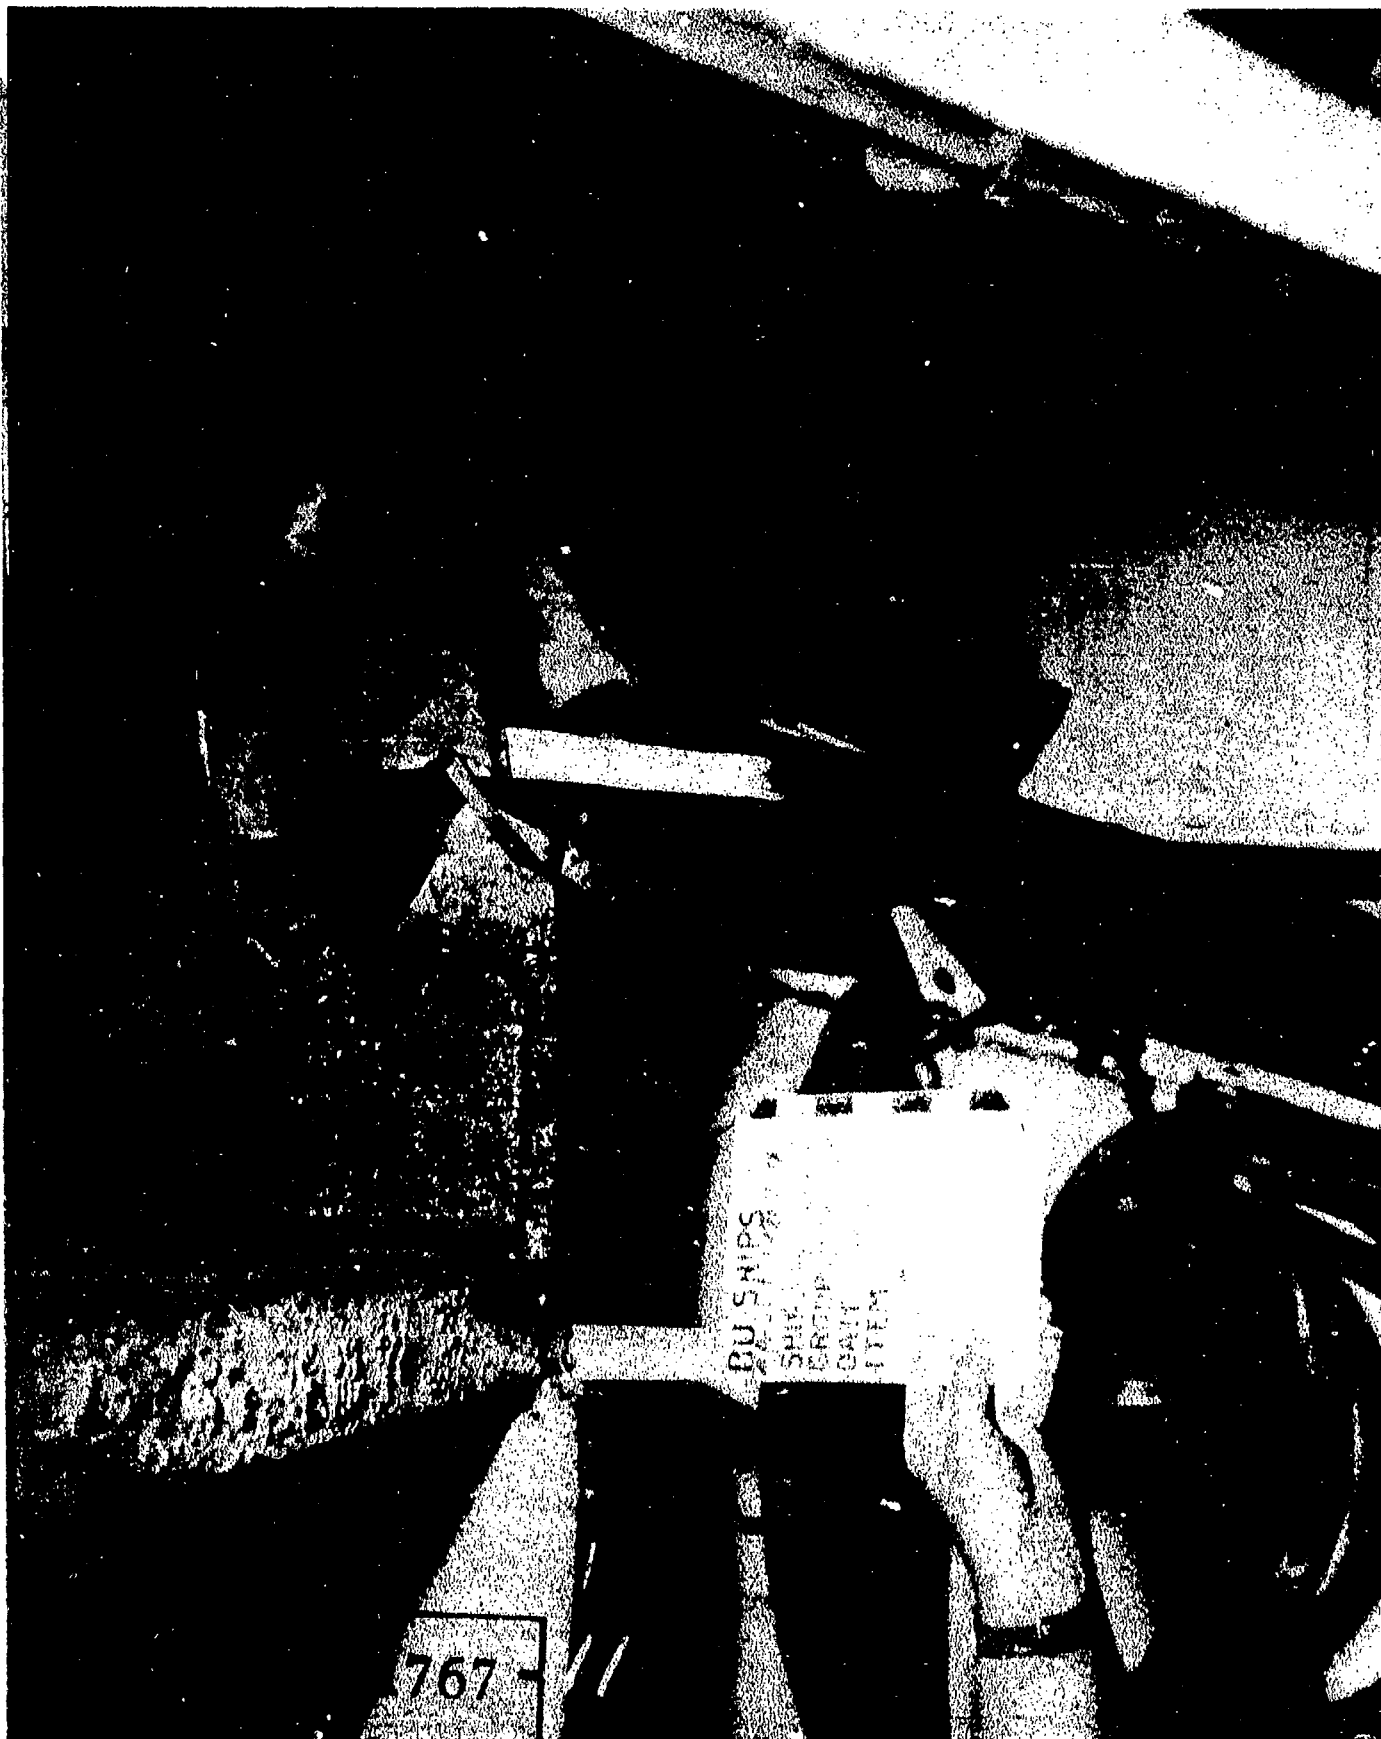
AA-CR-68-1767-11. C-201L. Looking to port on 2nd deck from centerline in crew's space showing failure of main deck longitudinal at frame 62 1/2.

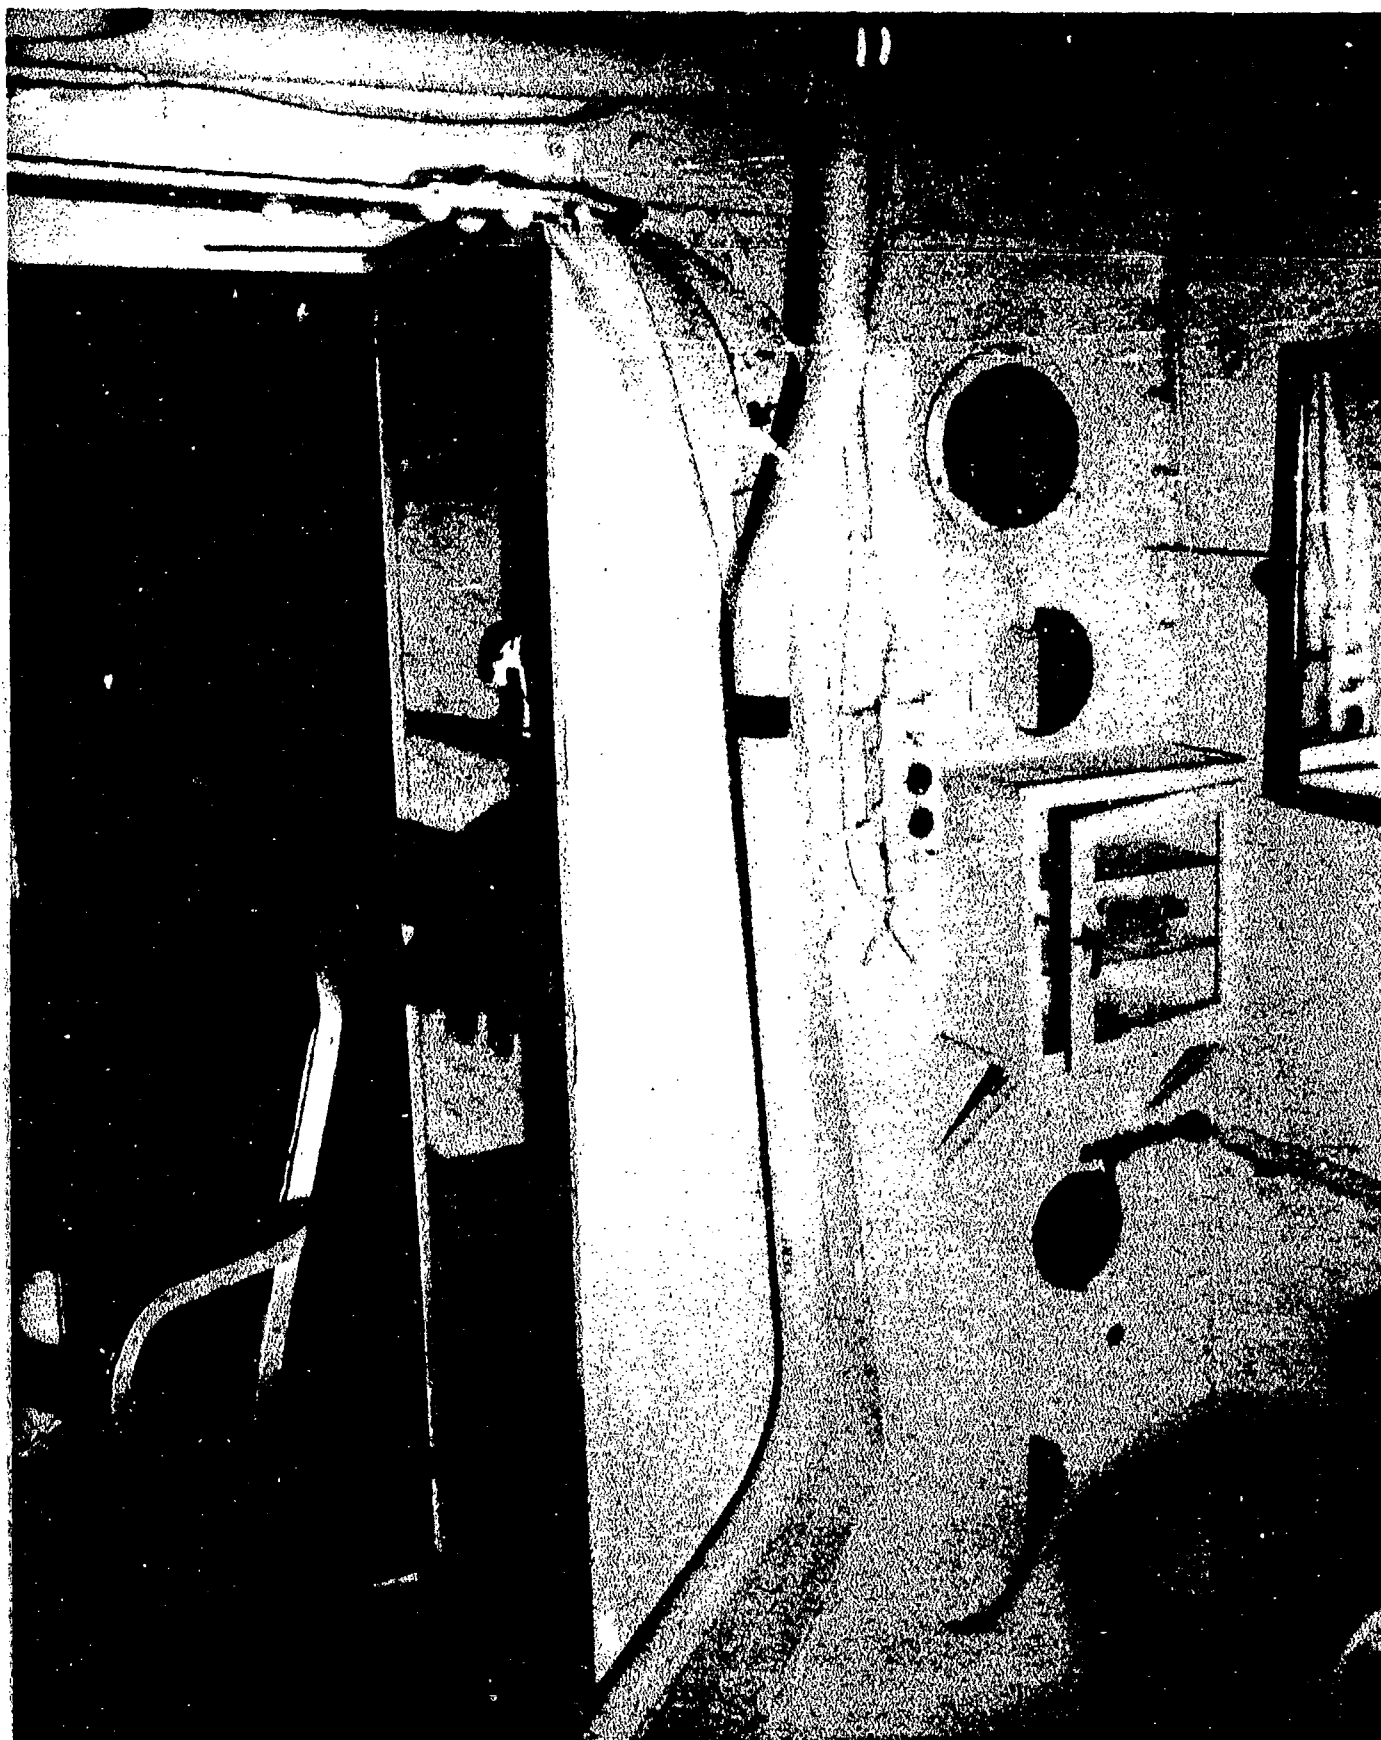
AA-CR-175-2157-11. Looking aft on 2nd deck port side in barber shop showing damage to web frame 65.

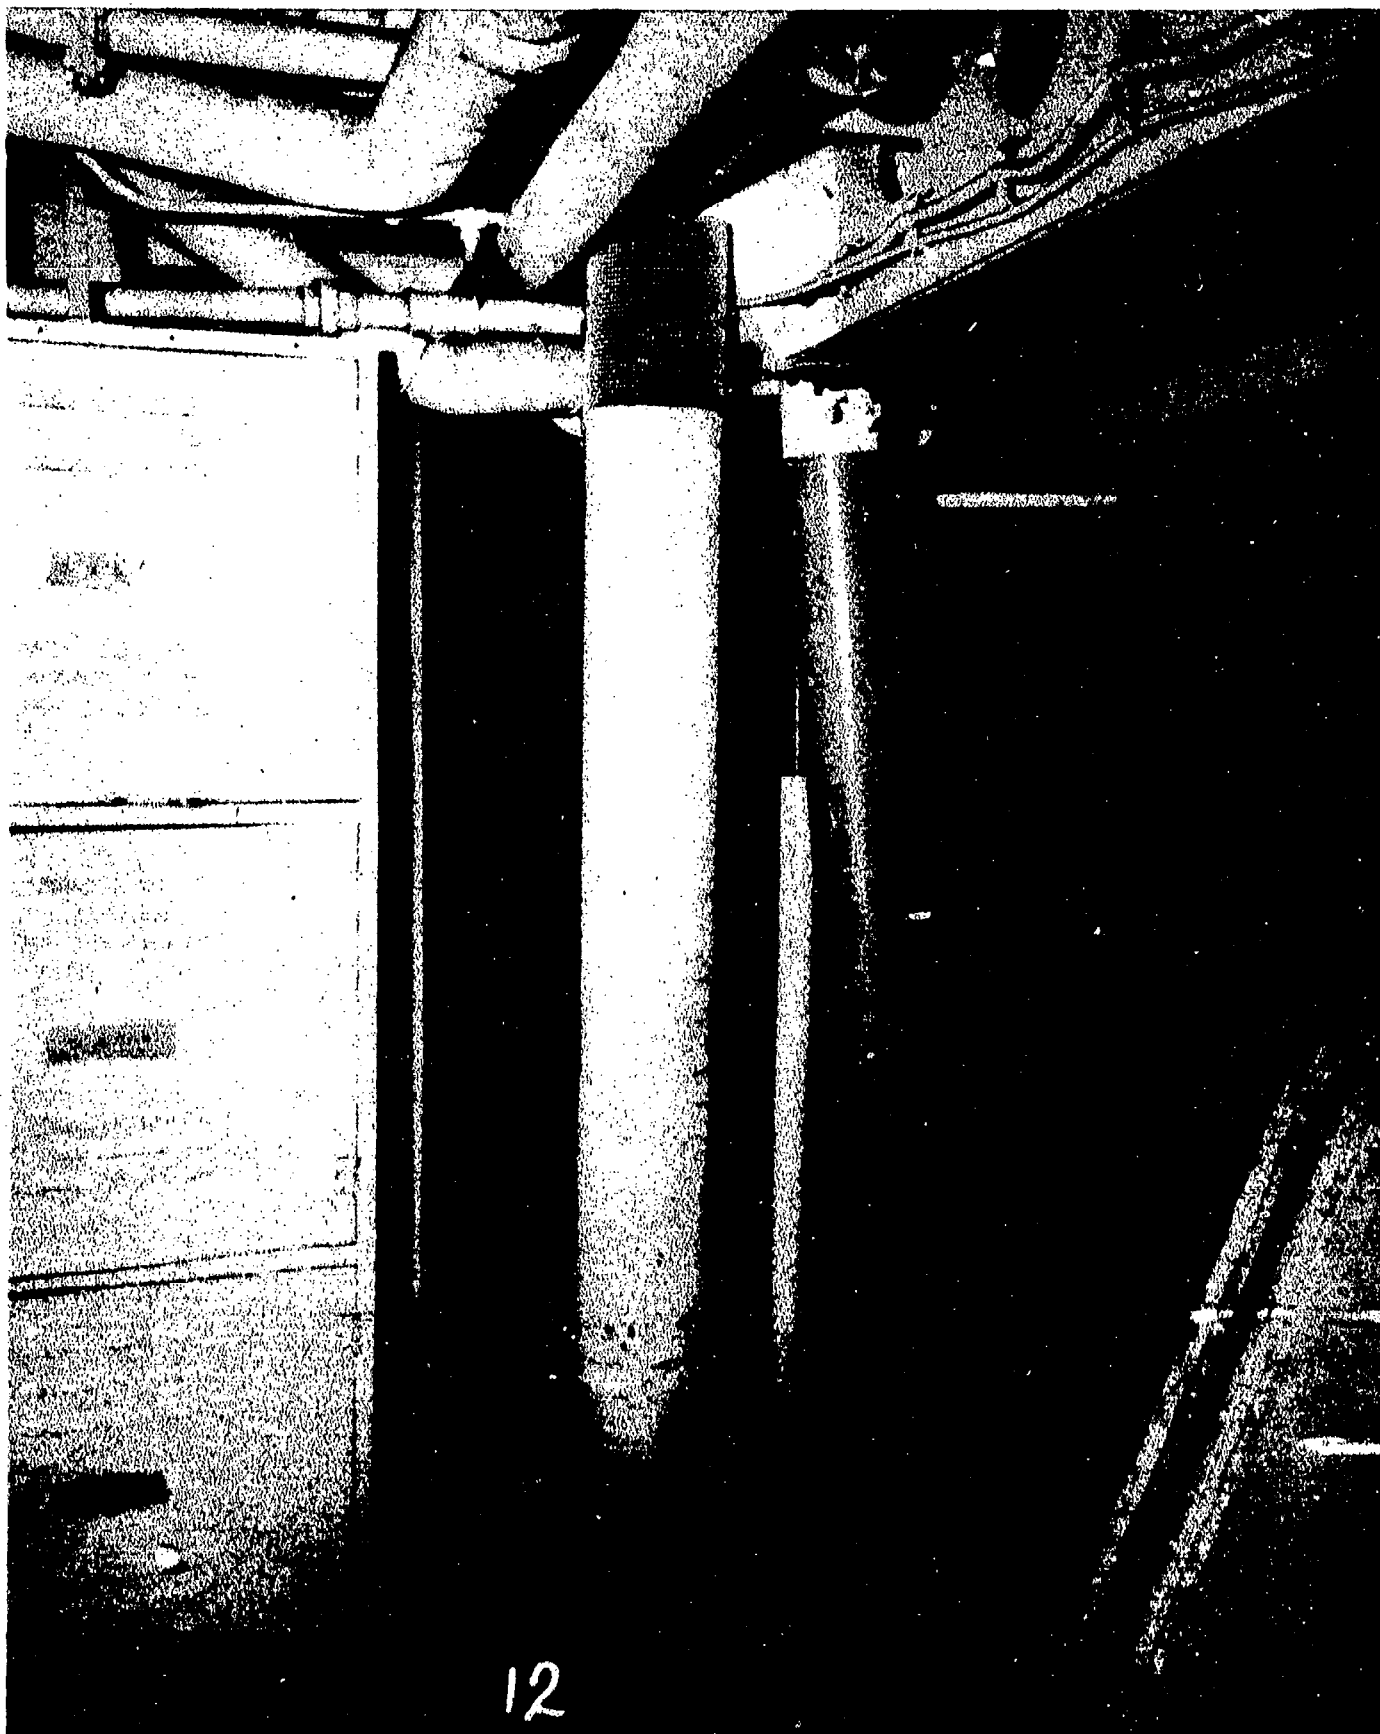
AA-CR-90-574-12. C-202-L. Second deck, frame 97, port side. Note deformation of stanchions and crack around top under beam.

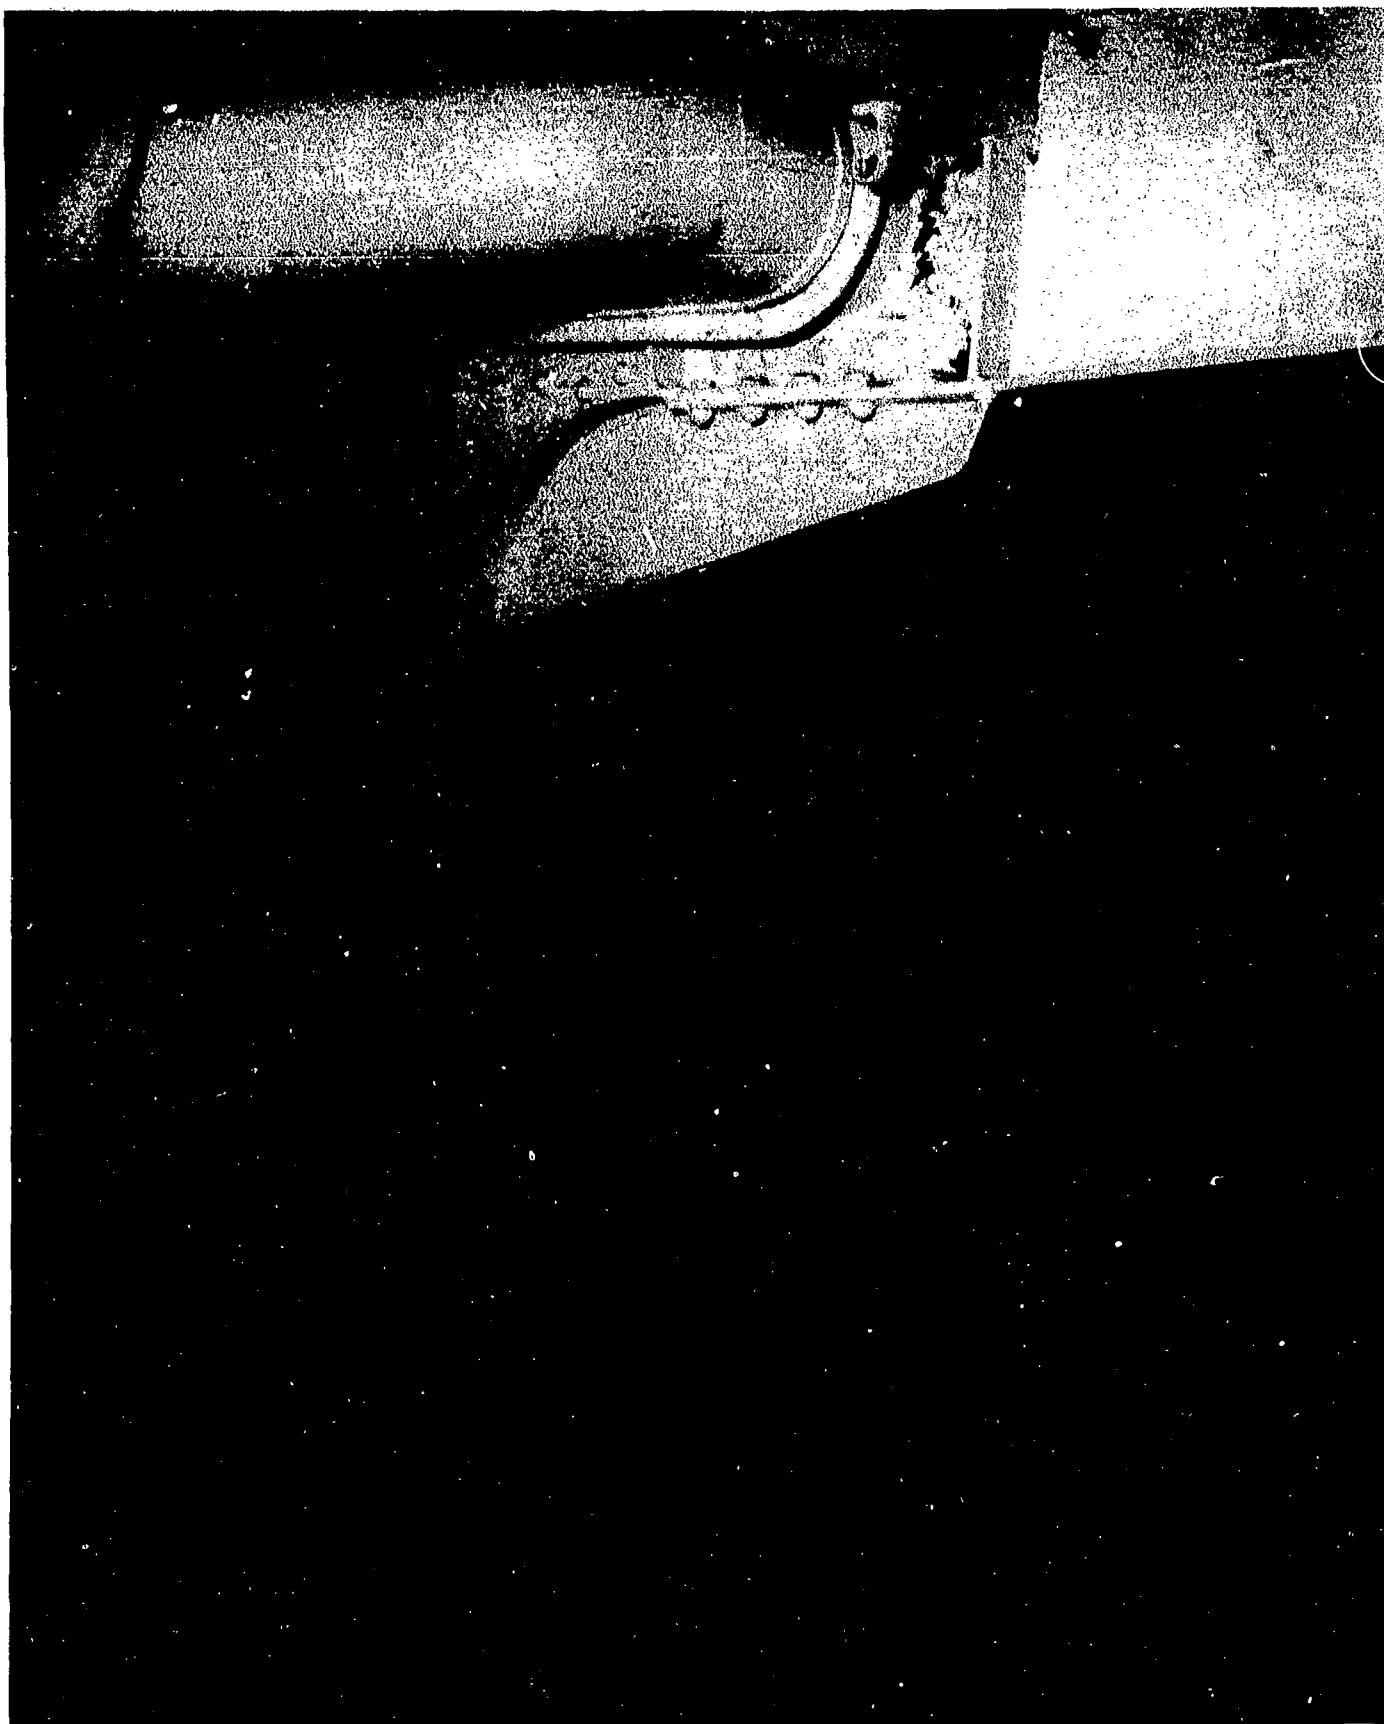
AA-CR-175-2178-6. Looking forward and to port shell on 2nd deck showing damage to web frame 122.

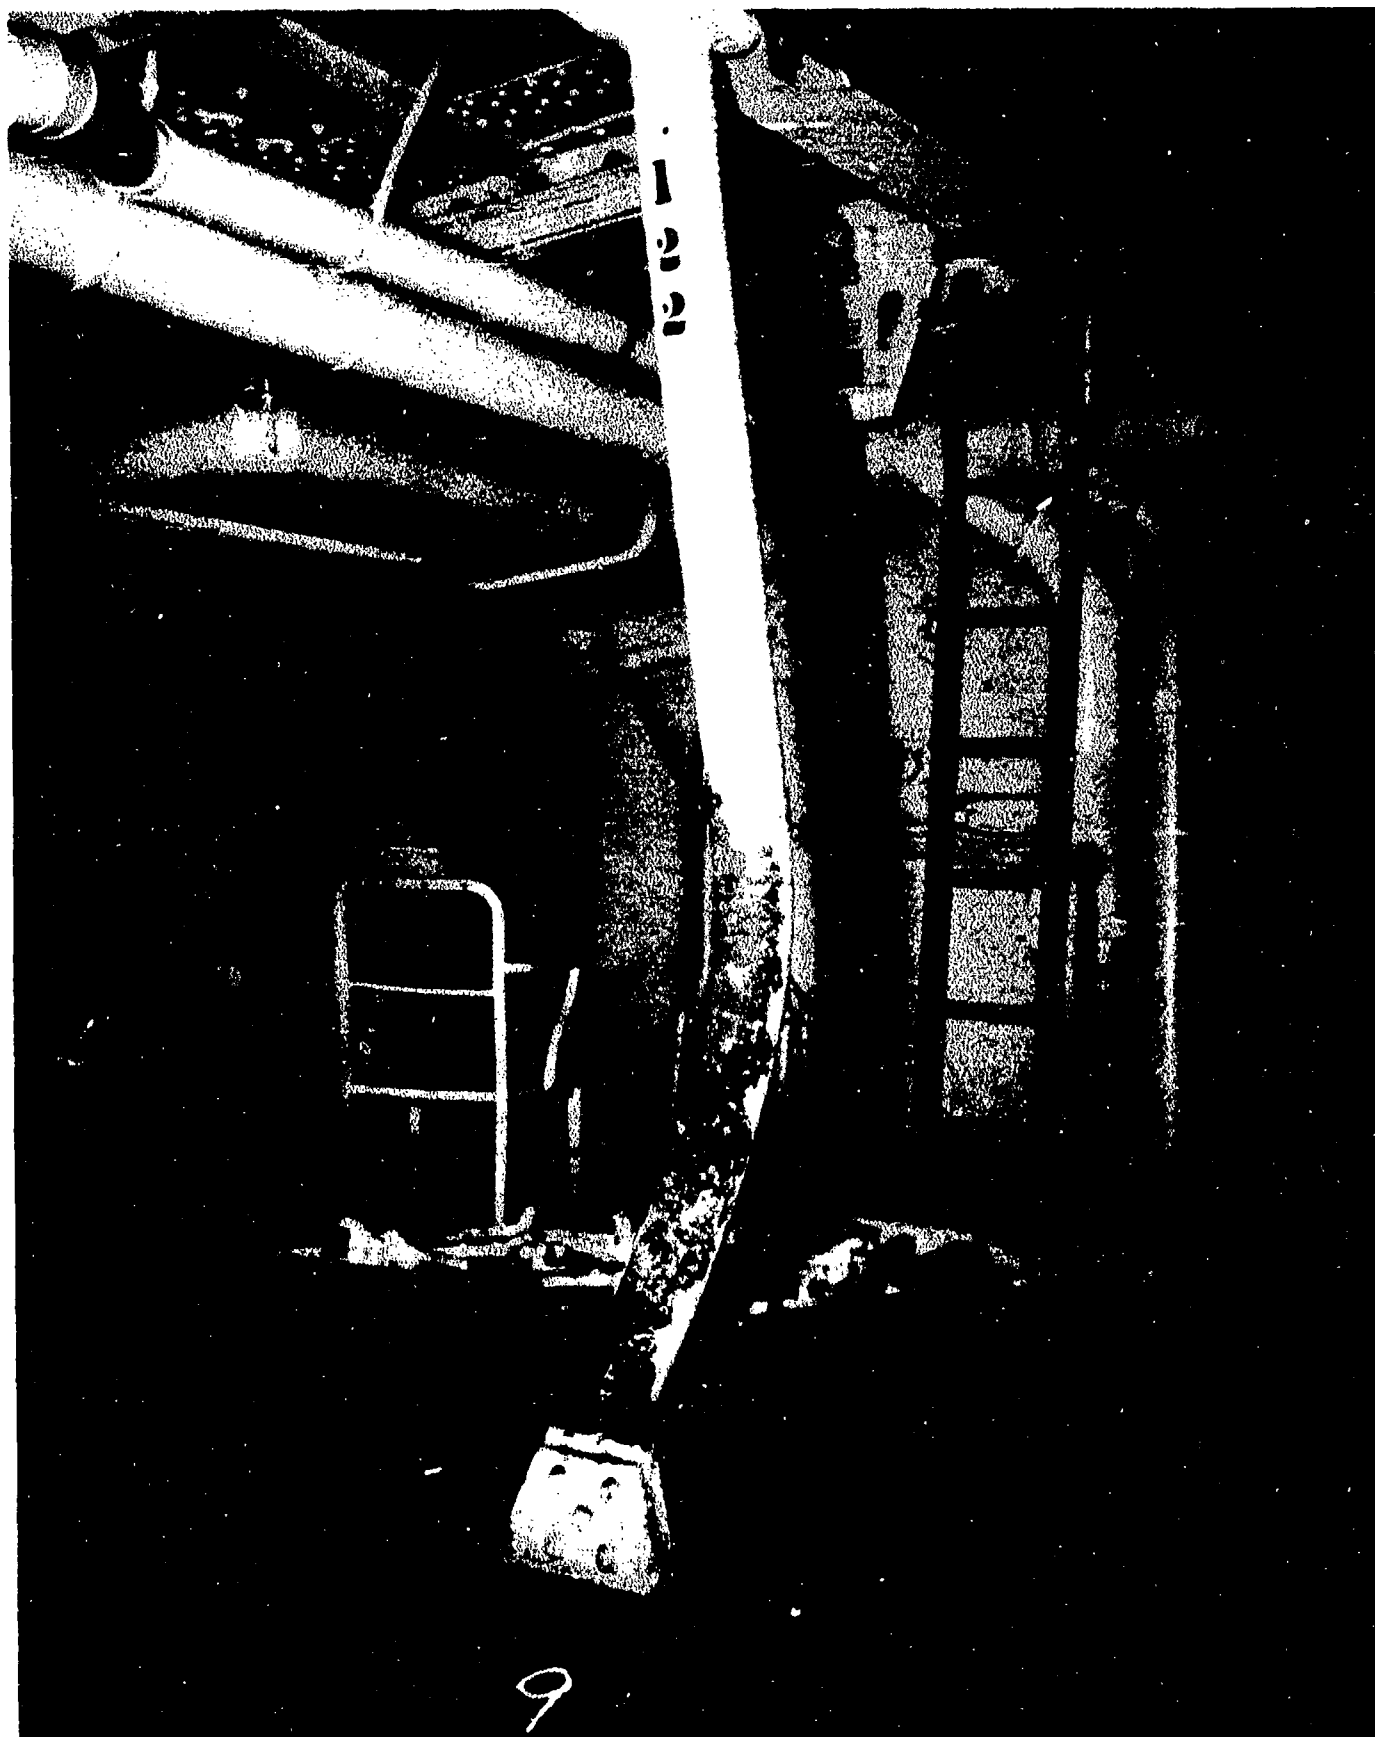
AA-CR-175-2178-9. Looking aft and to port on 2nd deck, starboard side, showing stanchion failure at web frame 122.

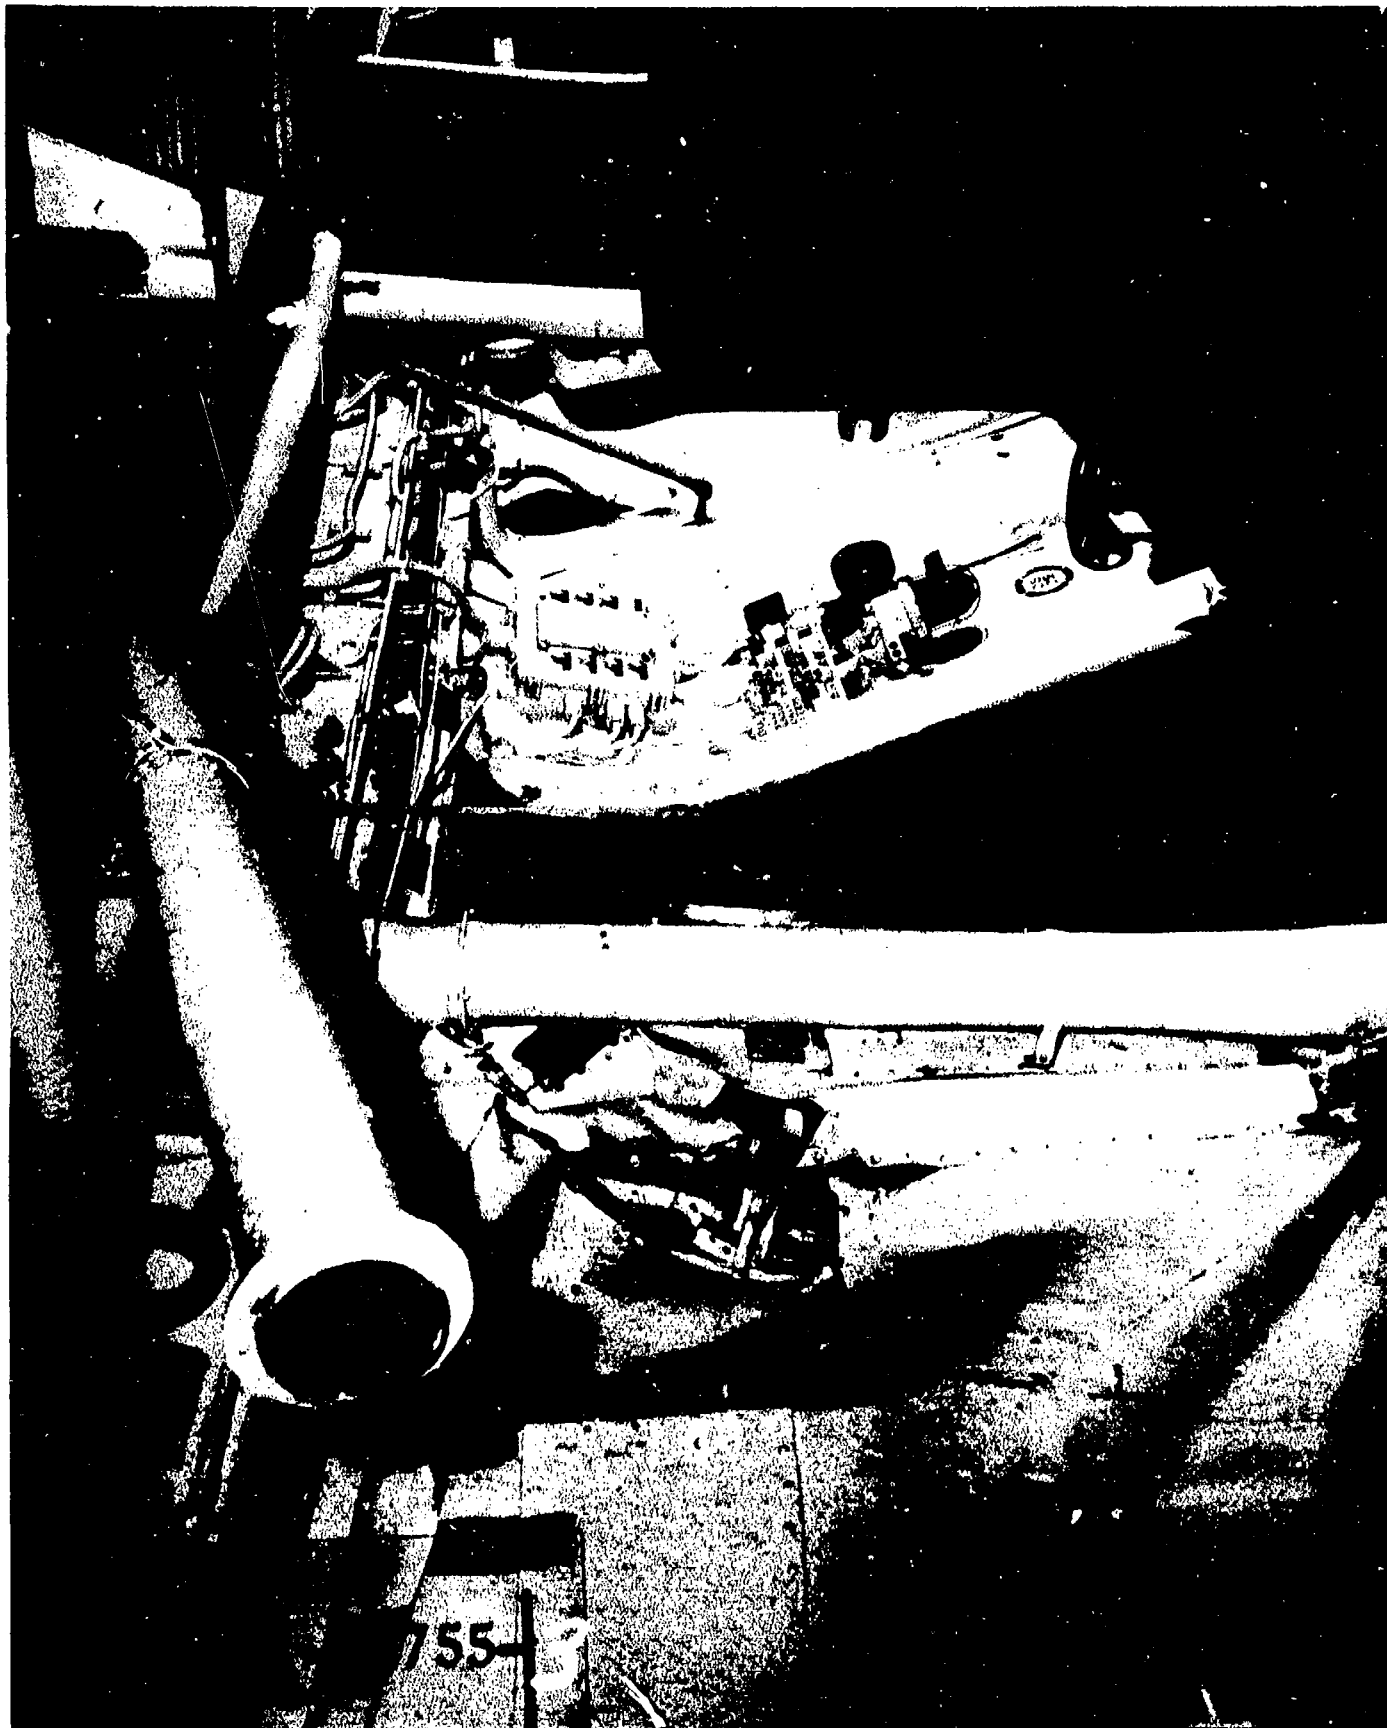
AA-CR-68-1755-3. D-203-L. Test A damage. Looking aft and to port at bulkhead 128, starboard.

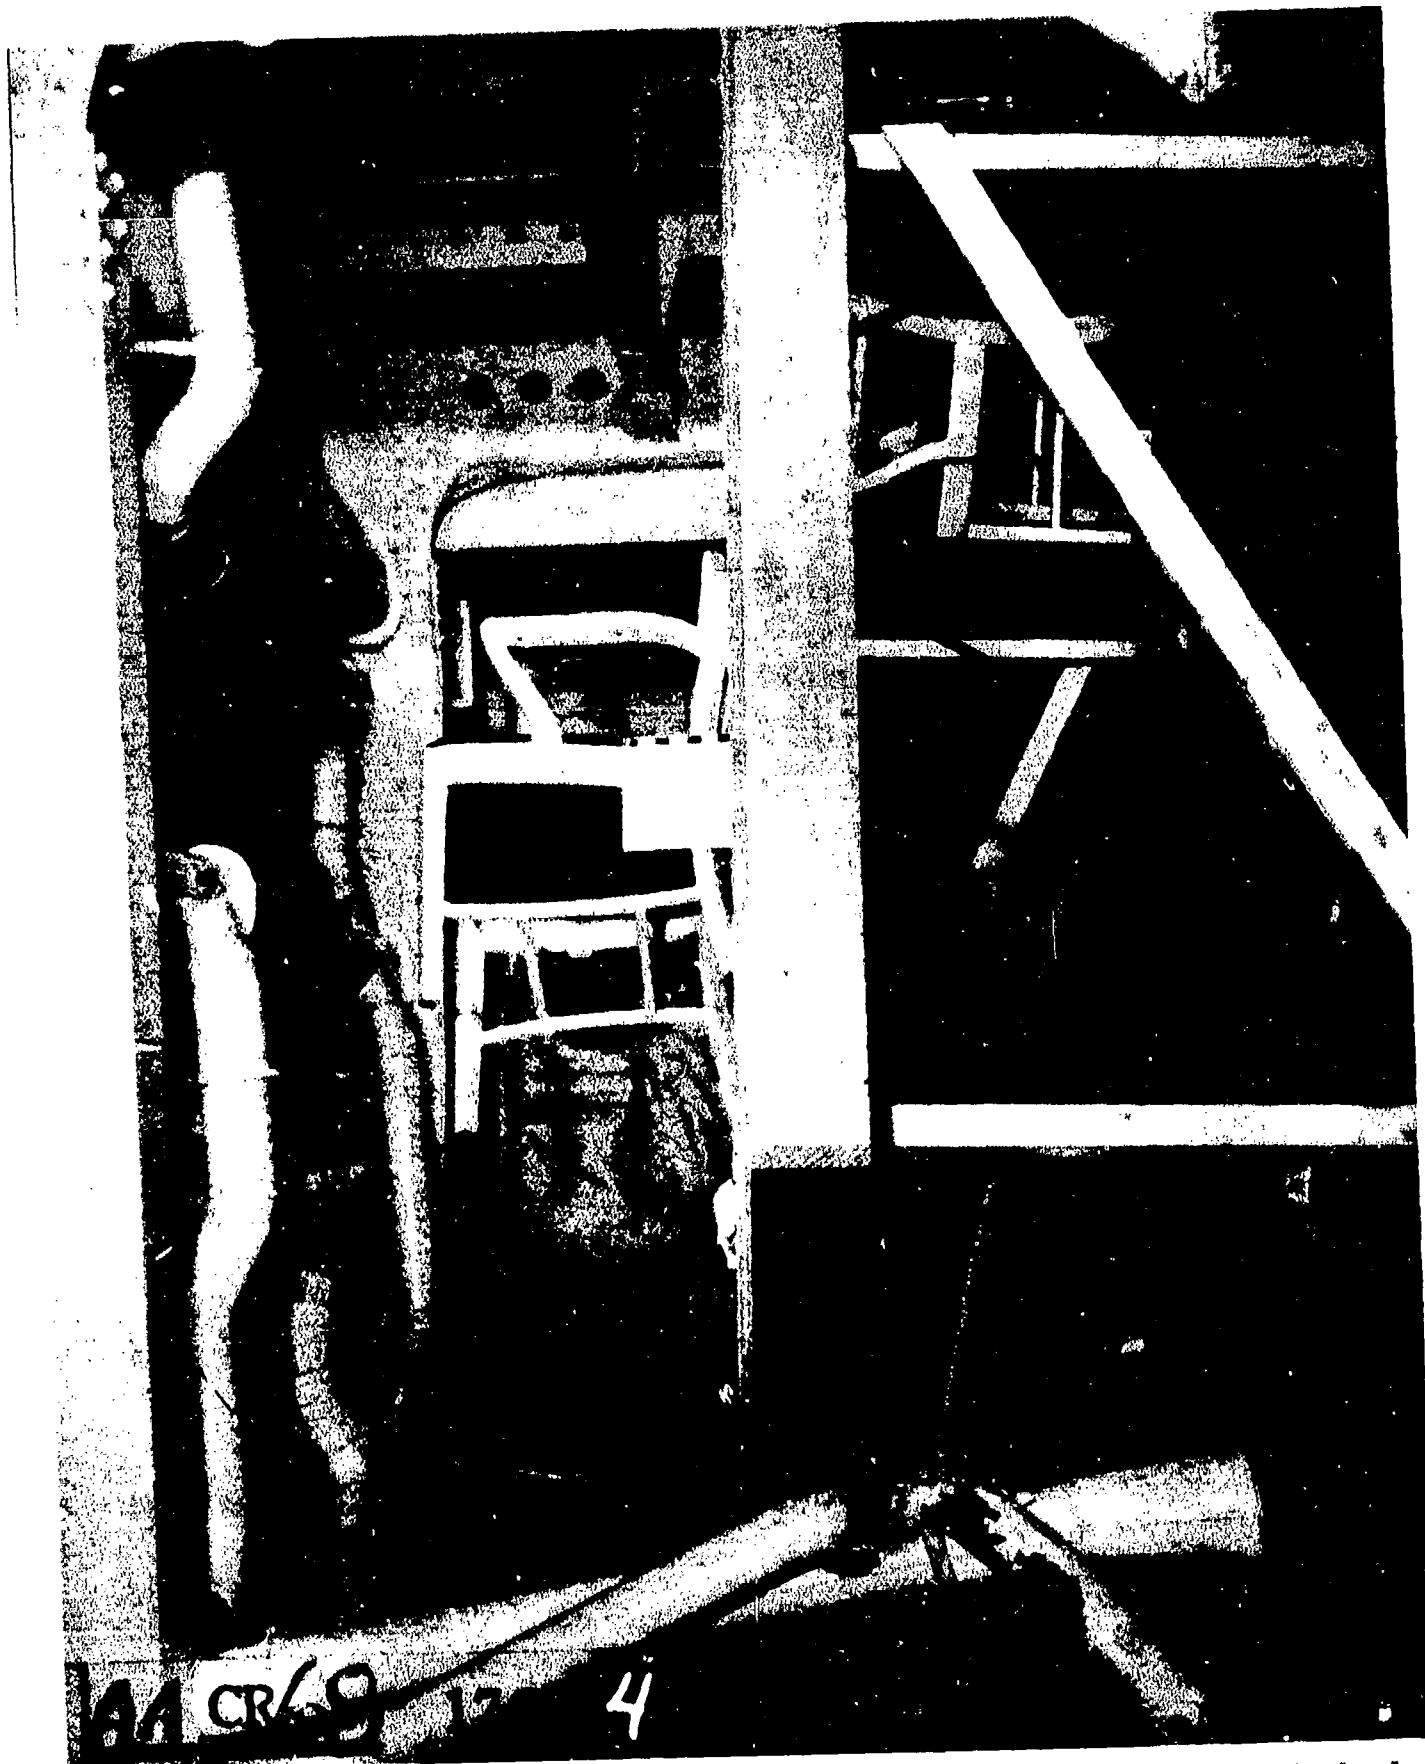
AA-CR-68-1765-4. Compartment D-203-L. Crew's space, 2nd deck, details of damage to frame 125, looking forward from frame 128.

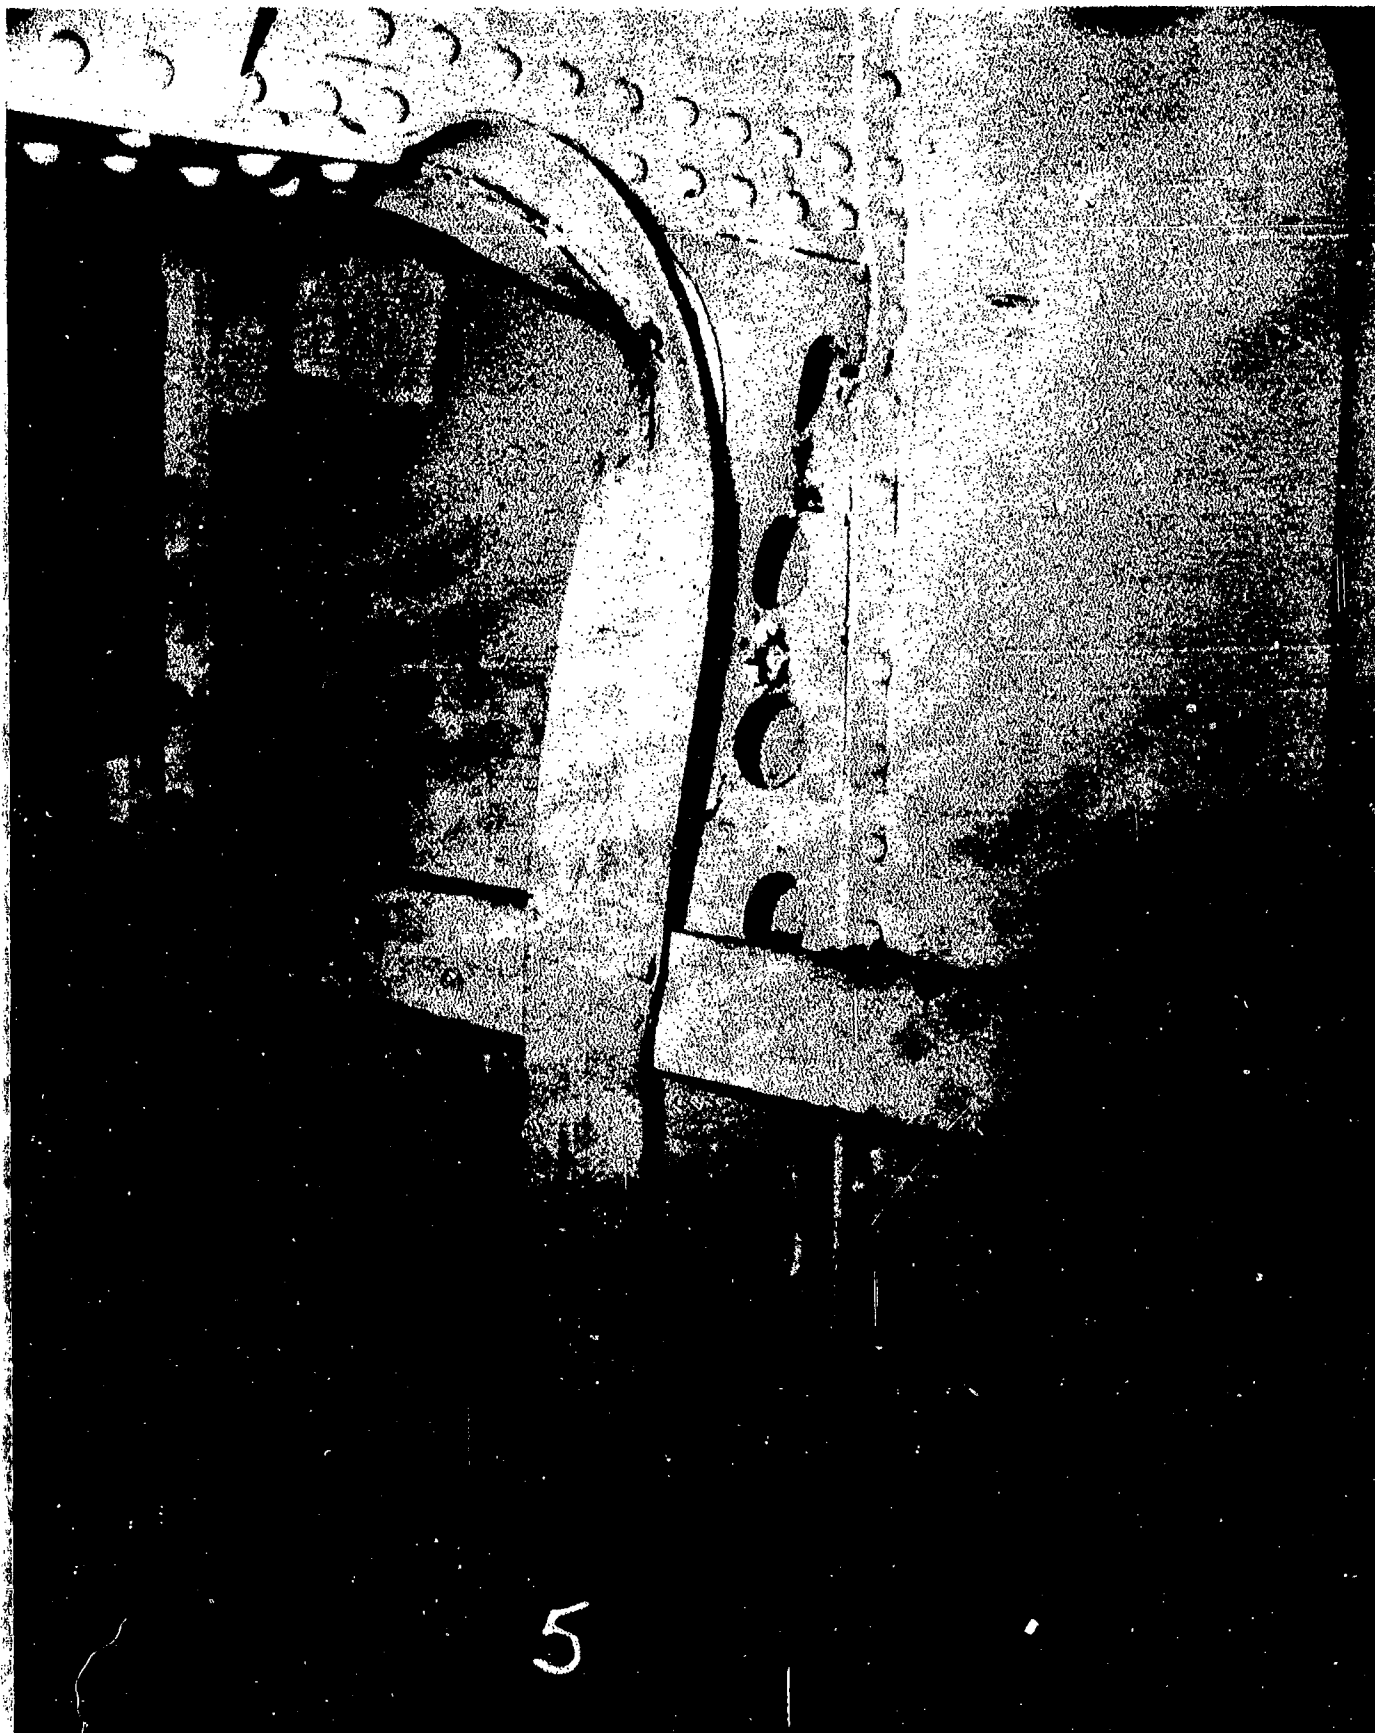
AA-CR-175-2178-5. Looking aft and to port shell on 2nd deck showing failure of web frame 125.
